Case study on the analgesic effect of the REPULS® VET Red Light Radiation Lamp in a horse with chronic tendinitis of the superficial flexor tendon (Edinger J.; Zsoldos R.) (Summary)

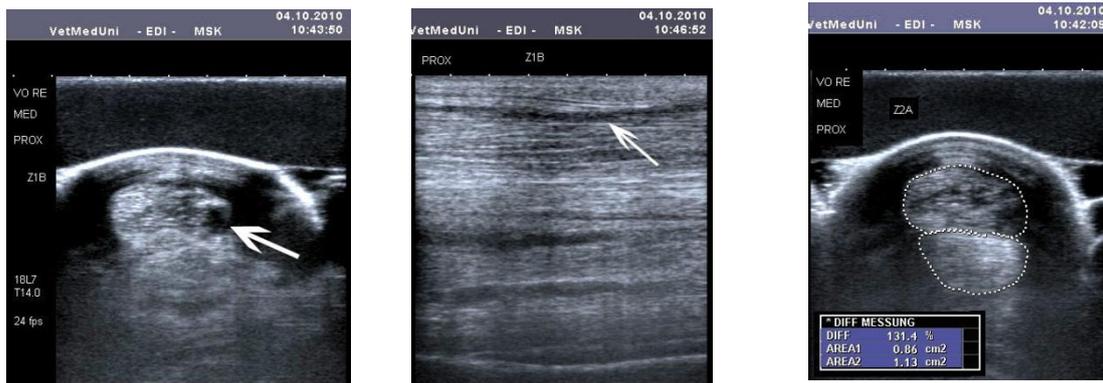
Figure 1: A Transverse sonogram of the area 2 A, the cross section is the clear Hypoechoogenität the superficial flexor tendon with acute damage to the lateral border of the tendon visible (arrow). B longitudinal sonogram in the area of acute tendon injury (arrow). C Transverse sonogram of the zone 2A comparative measurement of the cross-sectional areas of the superficial and deep flexor tendon.

At the time of re-admission to hospital the superficial flexor tendon was thickened front right slightly painful and clear. The sonography examination showed significant lesions on the superficial flexor tendon (Fig. 1). The management of anesthesia clearly confirmed the tendinitis as a cause of lameness.

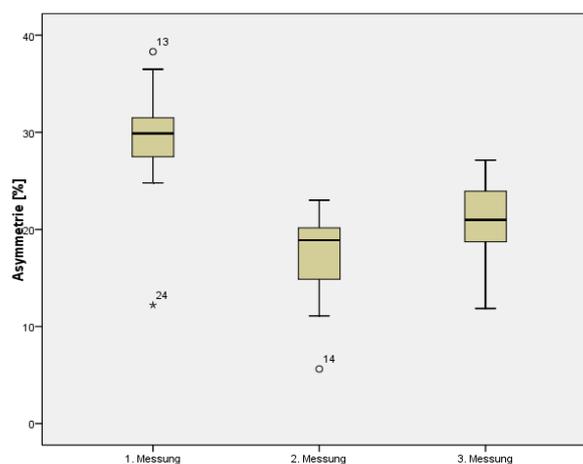
Table 1: Graph of the average and variations of the asymmetry between left and right forelimbs of the three treadmill measurements.

In the first measurement they detected an asymmetry in the curve between the left and right forelimb . In the subjective assessment on a straight line, the lameness was classified as grade 2-3/5. After the irradiation with the **REPULS ® VET Red Light Radiation Lamp**, a marked reduction in the asymmetry observed in the curve. The statistical analysis of the measurement showed a significant improvement of the lameness on the treadmill. In the subjective assessment the lameness was classified as grade 1-2/5. The third treadmill measurement a week showed after the irradiation again a mild increase of lameness. The measurement results of the third treadmill measurement one week after finishing the irradiation treatment there was again a significantly elevation of the lameness. The results of the third measurement where significantly worse than the second measurement, but also significantly better than the first measurement (Table 1).
